**INSPECTION REPORT: BULK ASBESTOS SURVEY  
SAN YSIDRO BORDER CROSSING  
BUILDING CA0588  
720 E. SAN YSIDRO  
SAN DIEGO, CA 92115**

**GSA Contract No.: GS-09P-07-NQ-M-0023**

**SCA Project No.: G-8452**

**JUNE 2007**

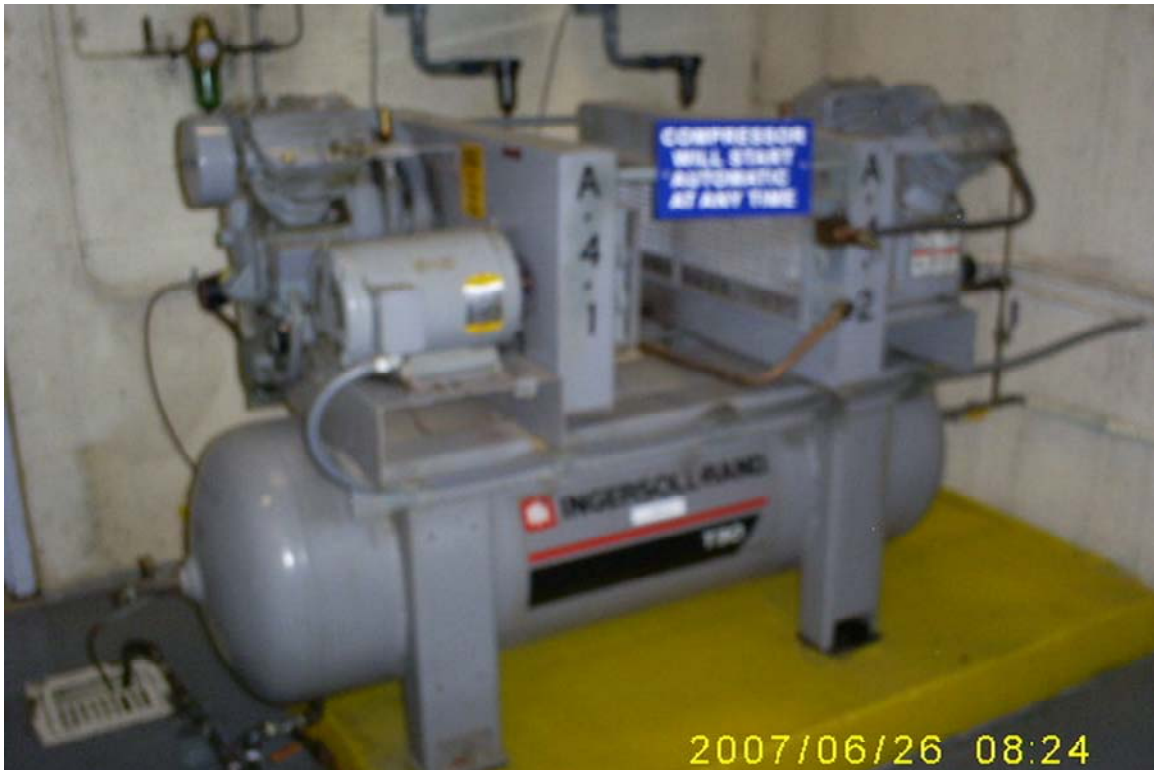
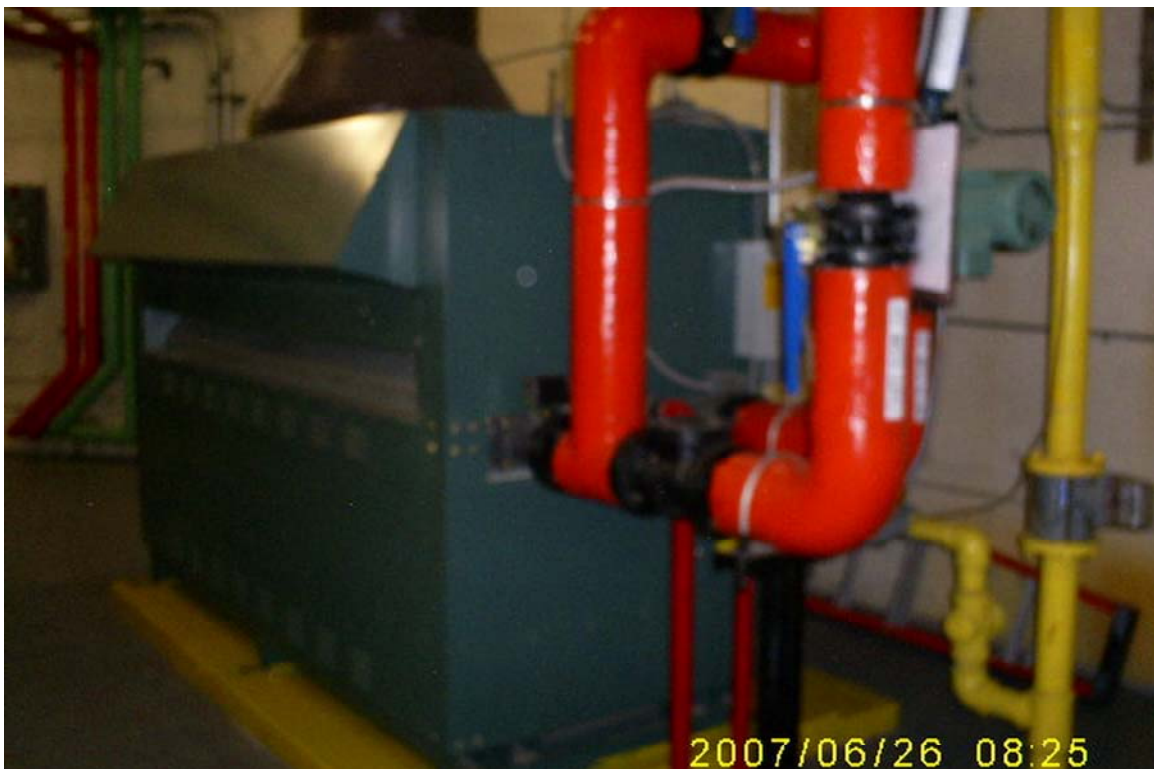
*Above & below: East Mechanical mechanical equipment & non-suspect PI-NNN*

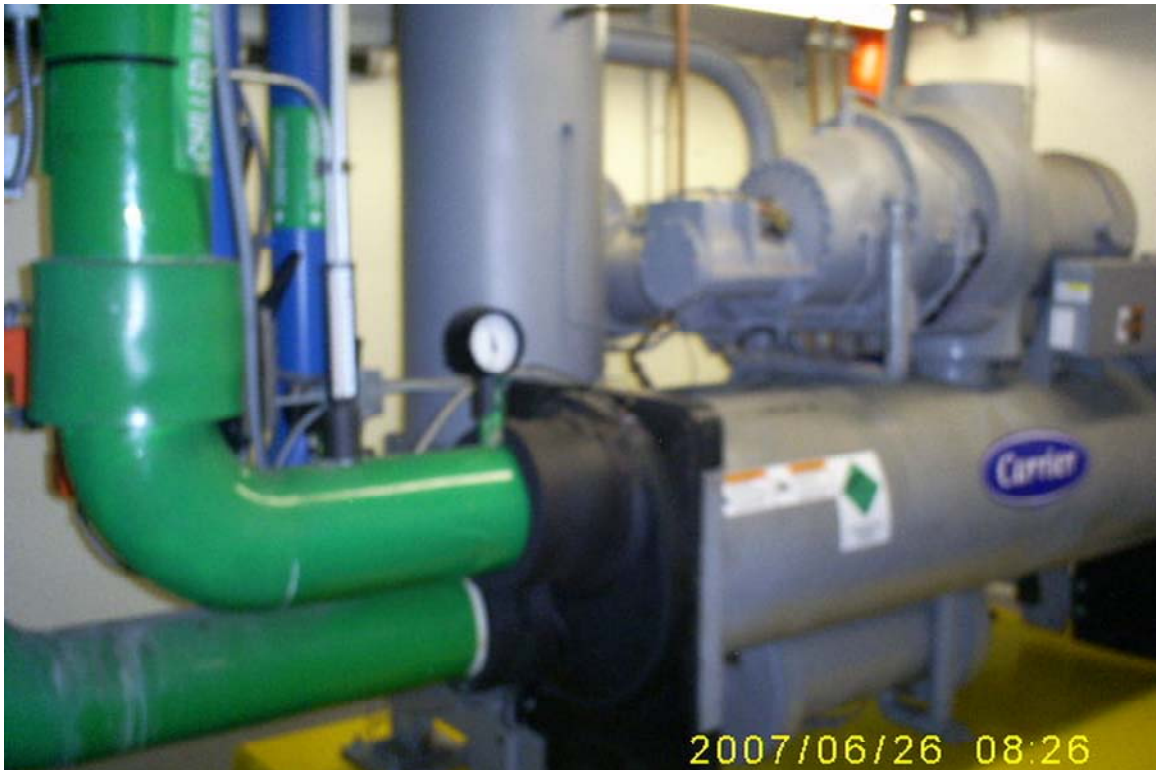
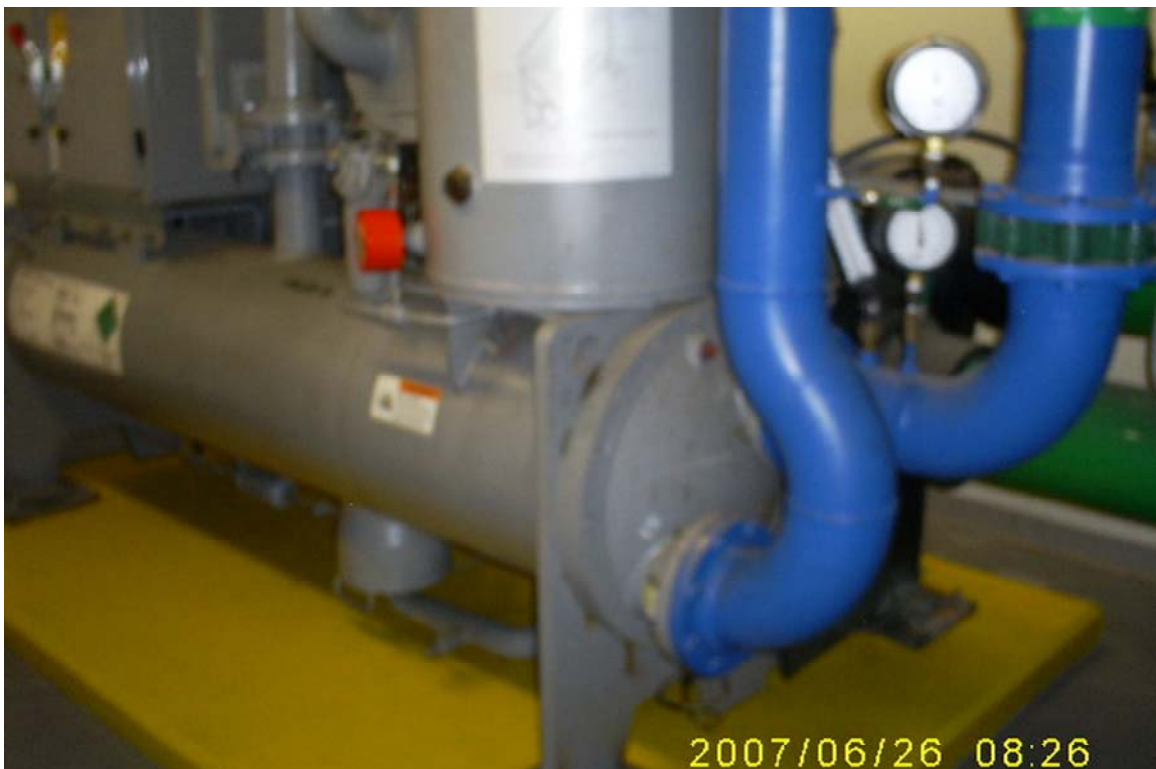
*Above & below: East Mechanical mechanical equipment & non-suspect PI-NNN*

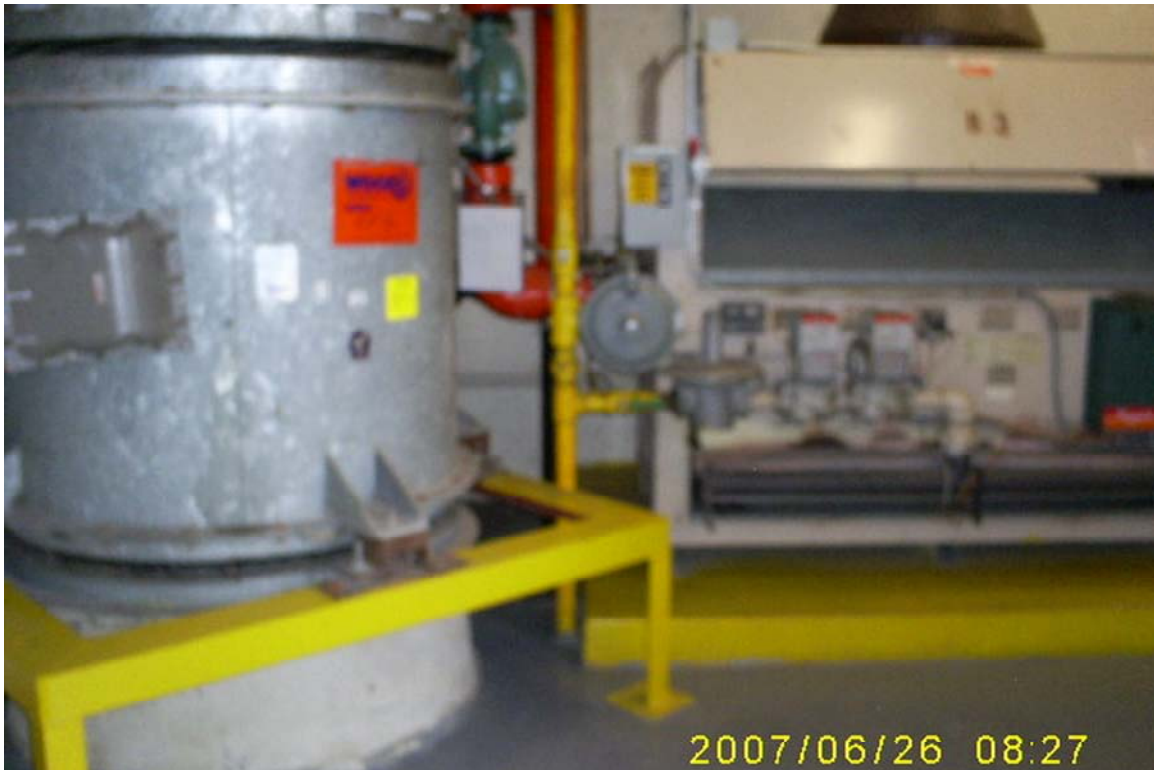
*Above: East Mechanical mechanical equipment & Non-suspect PI-NNN*

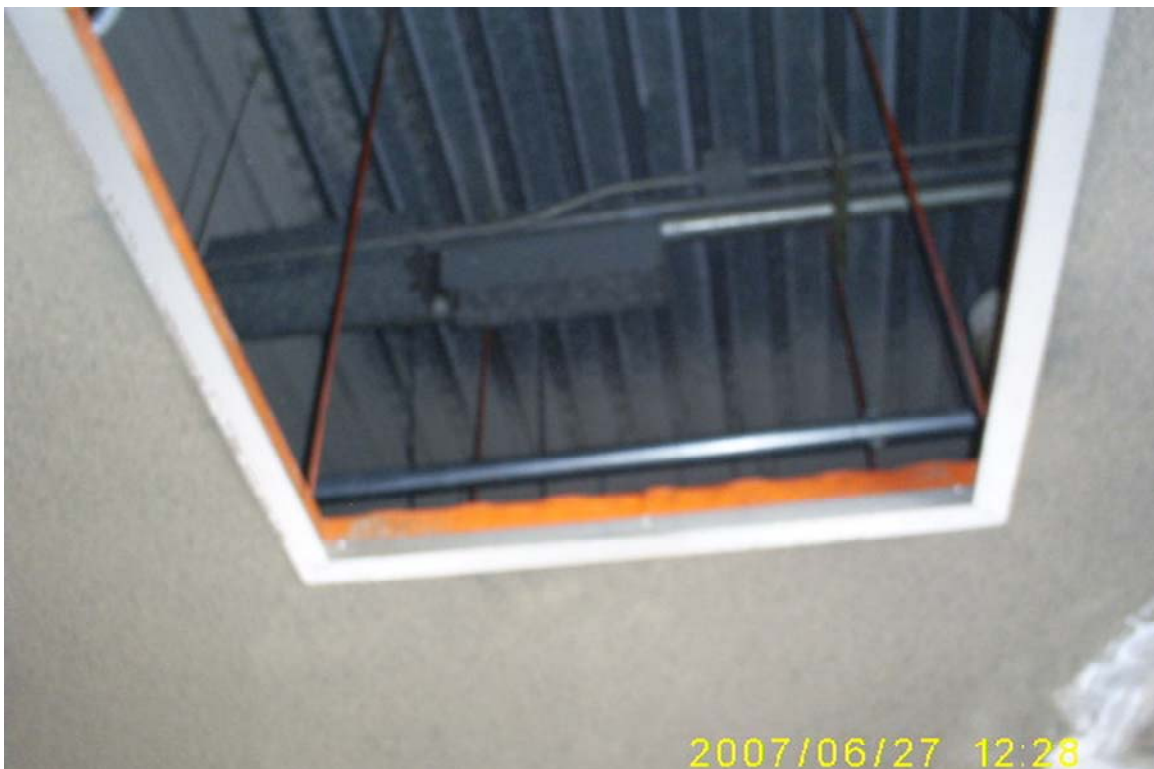
Records indicate that HA 300 was not abated from the main canopy (2002 Cal Inc. Environmental Audit Compliance Report, Attachment 9, 1987 Industrial Health Inc. FAAP). This area was instead enclosed in a rigid barrier of lath and stucco with access hatches for maintenance personnel. SCA visually inspected this area with the assistance of maintenance personnel and a scissor lift. Upon entering the main canopy soffit, SCA noted the presence of ACM structural fireproofing debris settled throughout the space. While SCA was equipped with proper respiratory protection and training, maintenance personnel were unequipped and untrained; as a result SCA was forced to vacate the area after only a brief visual inspection. No additional samples were collected from this inspection area. Photographs of this space are included in Attachment 5.

*Above: HA STSFP-300; Main Canopy Soffit from below*

Functional Space	Material Description	Qty	Recommended Response	Cost
<b>EXTERIOR</b>				
CANOPIES	Residual un-abated ACM structural fireproofing (1987 bulk sample ID's 130079 - 130083)	32000	Label canopy soffit access hatches with asbestos warning labels; Ensure that ONLY trained personnel with proper respiratory protection are allowed access to the space.	\$5,000

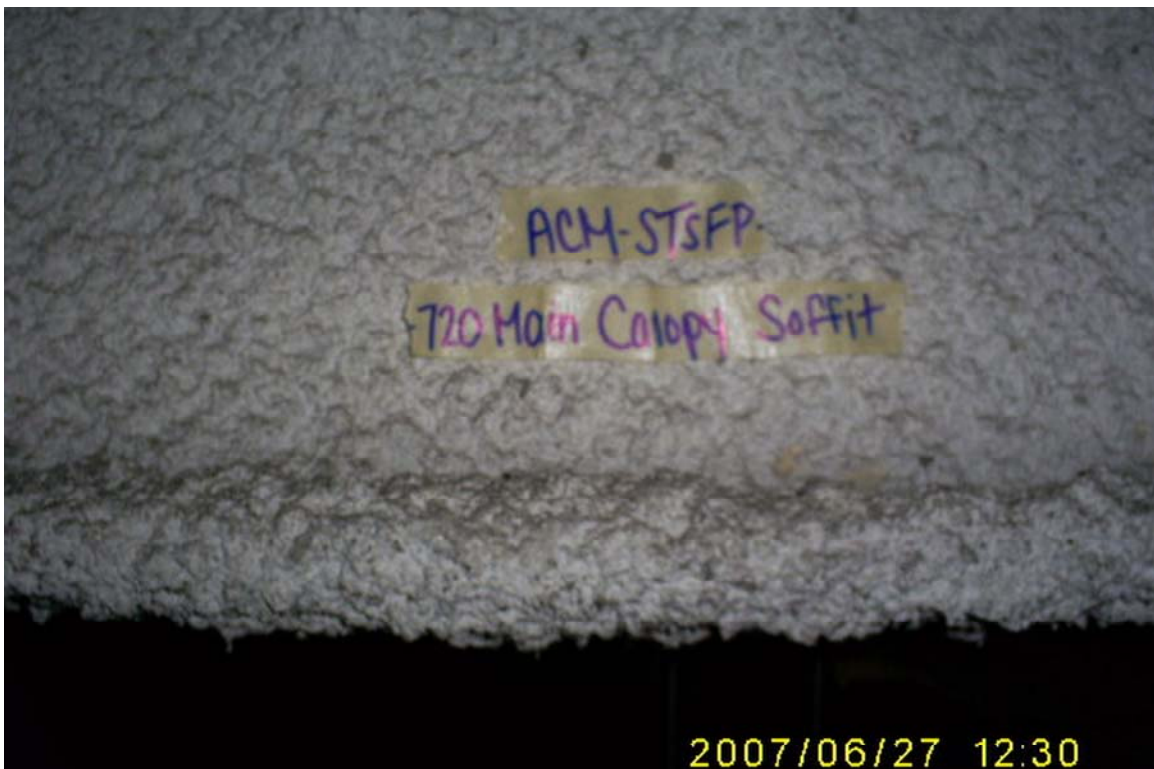
*Above & blow: Main Canopy Soffit;  
HA STSFP-300 & DHWMUD-325 & non-suspect PI-NNN*
